FIRKIN CRANE CONSERVATION MANAGEMENT PLAN

Firkin Crane, John Redmond Street, Shandon, Cork City

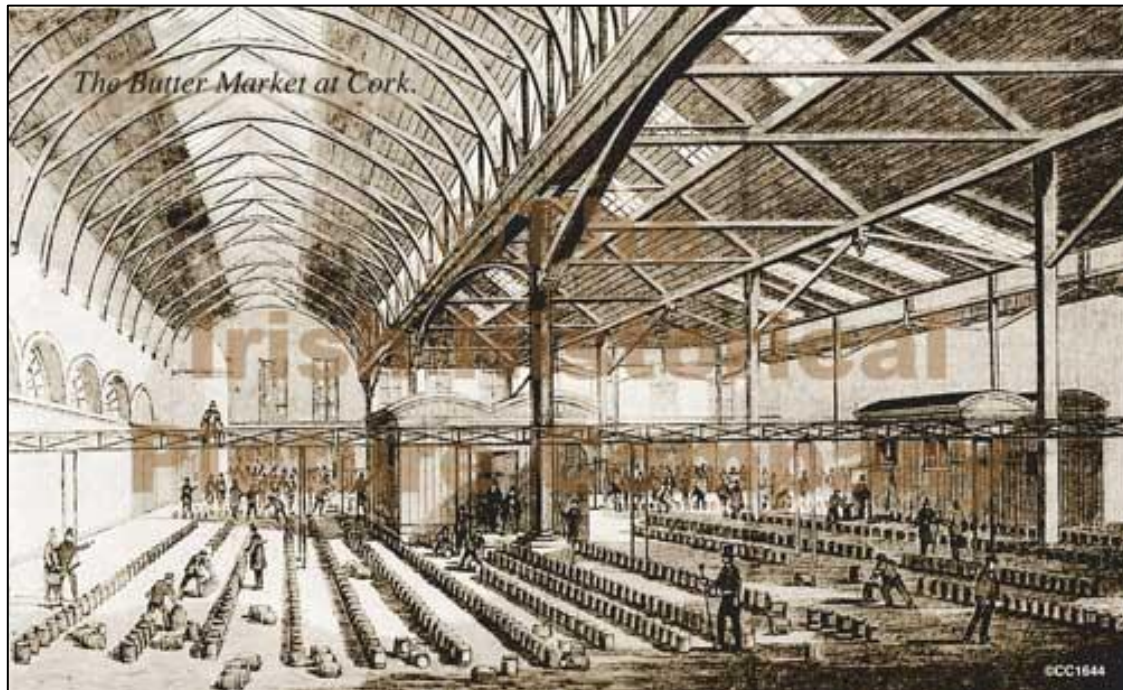
Plate 2 The Butter Market, adjacent to the Firkin Crane, in the nineteenth century (London Illustrated News)

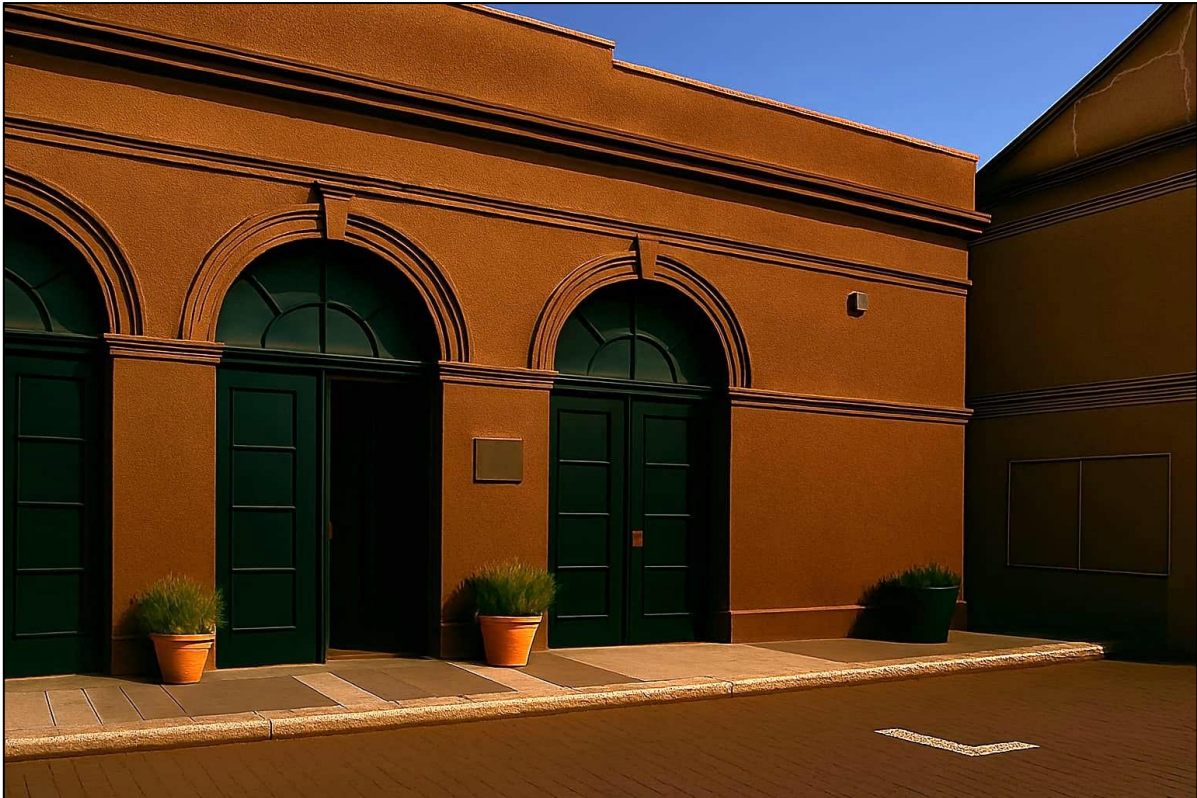
Plate 8 Developing a unified palette for all Benson buildings

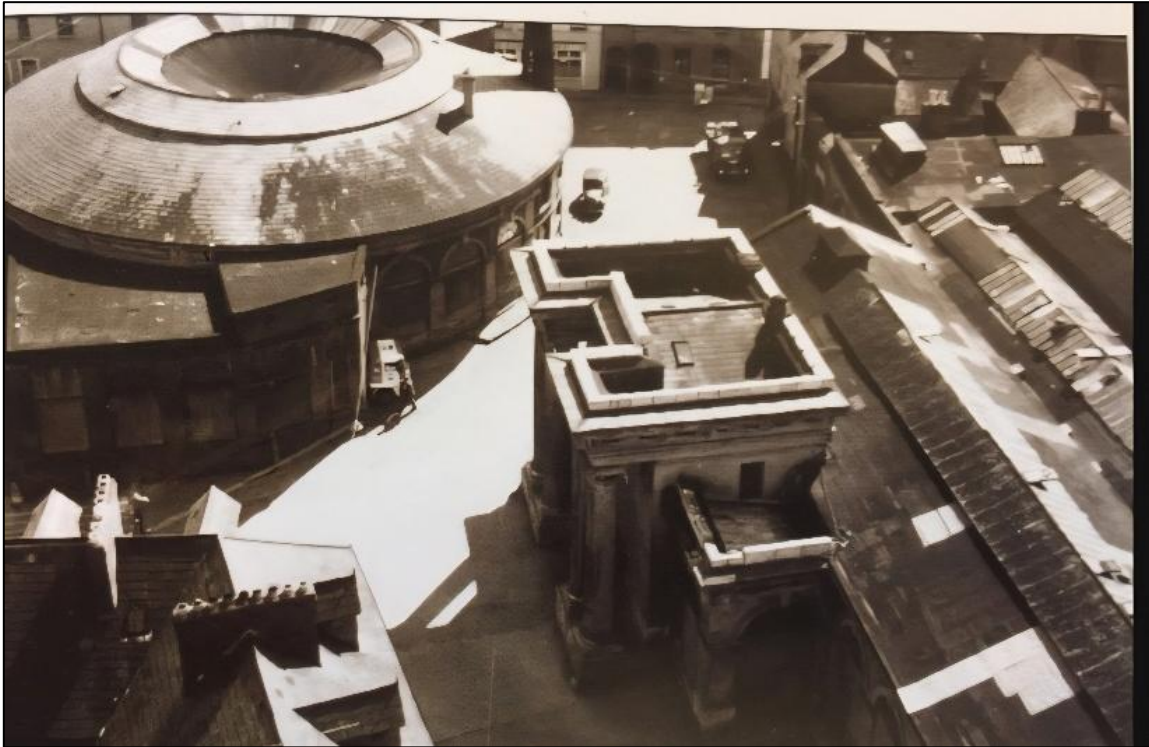
Plate 9 Aerial photograph showing original roof and central drainage arrangement of the roof of the Firkin Crane. Note additional structure at the ridge and also flat roofed extensions to the north elevation. Also visible is the Butter Market portico and roof over the market. C 1975

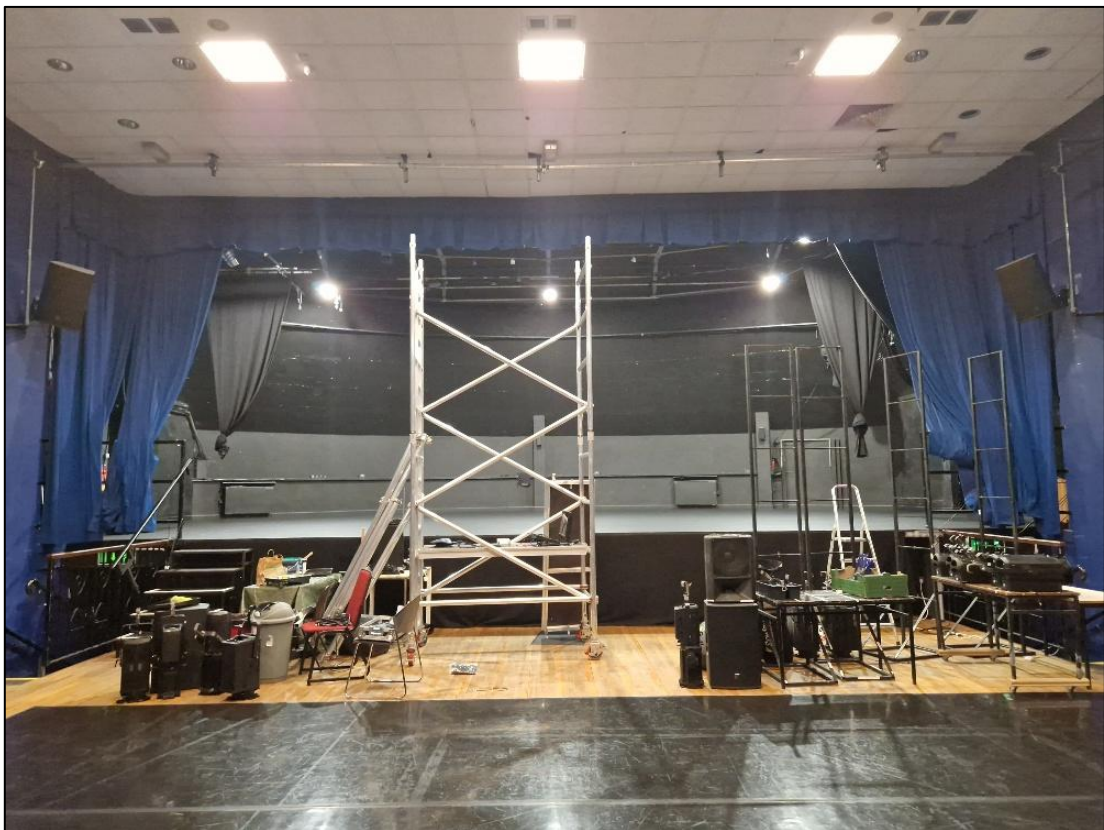
Plate 38 Upper stage with lighting access difficulties and roof leaks.

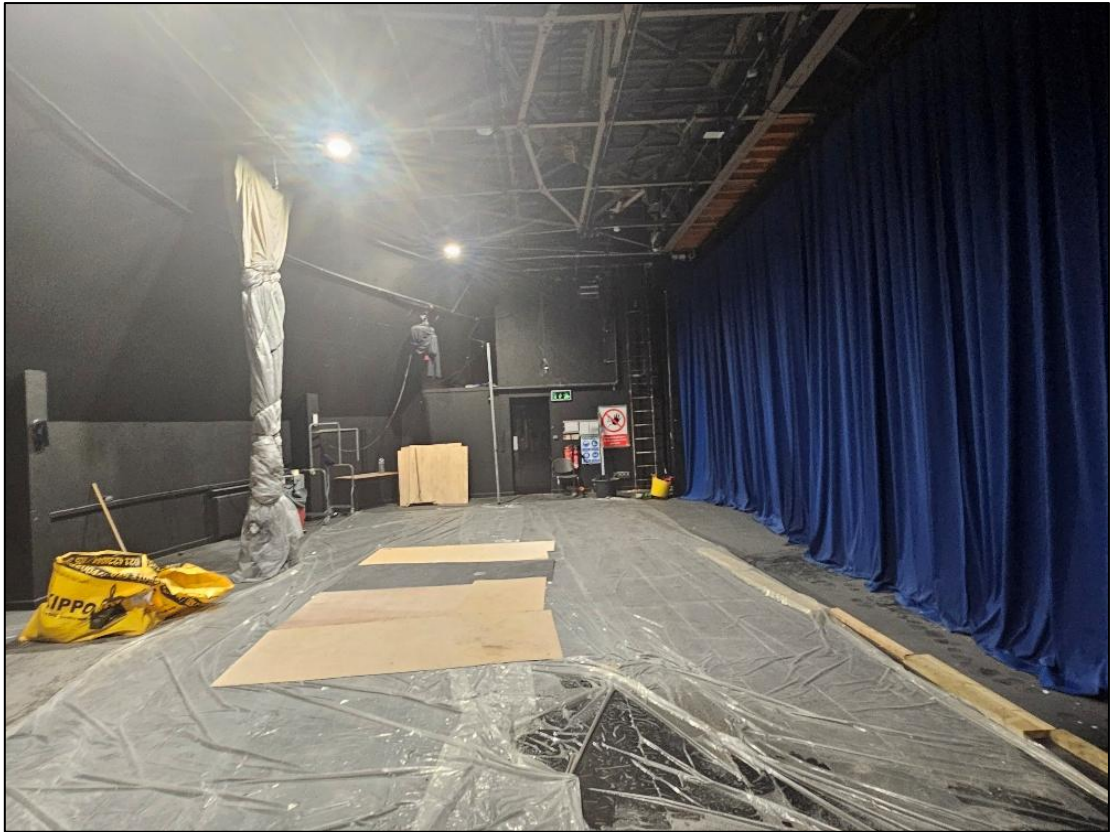
Plate 39 Roof repairs n 2025 will avoid further risks to dancers.

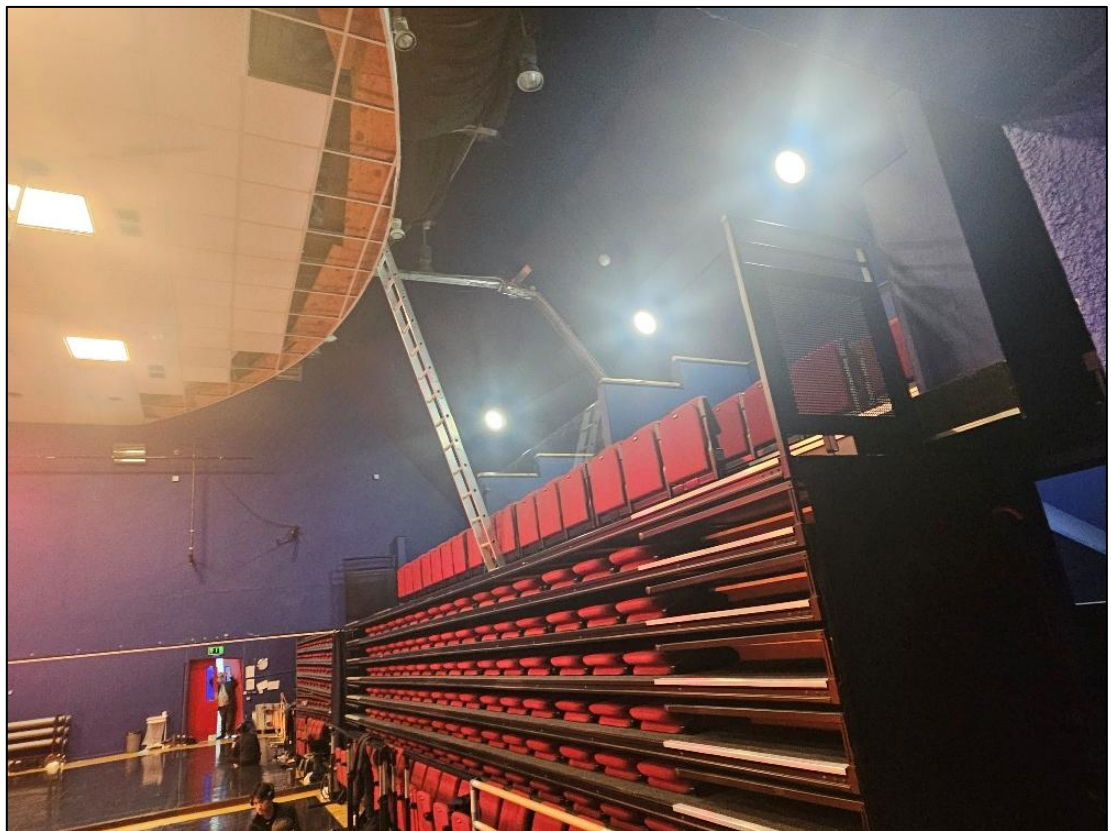
Plate 40 Folding tiered seating is functional but ladder indicates health and safety issues

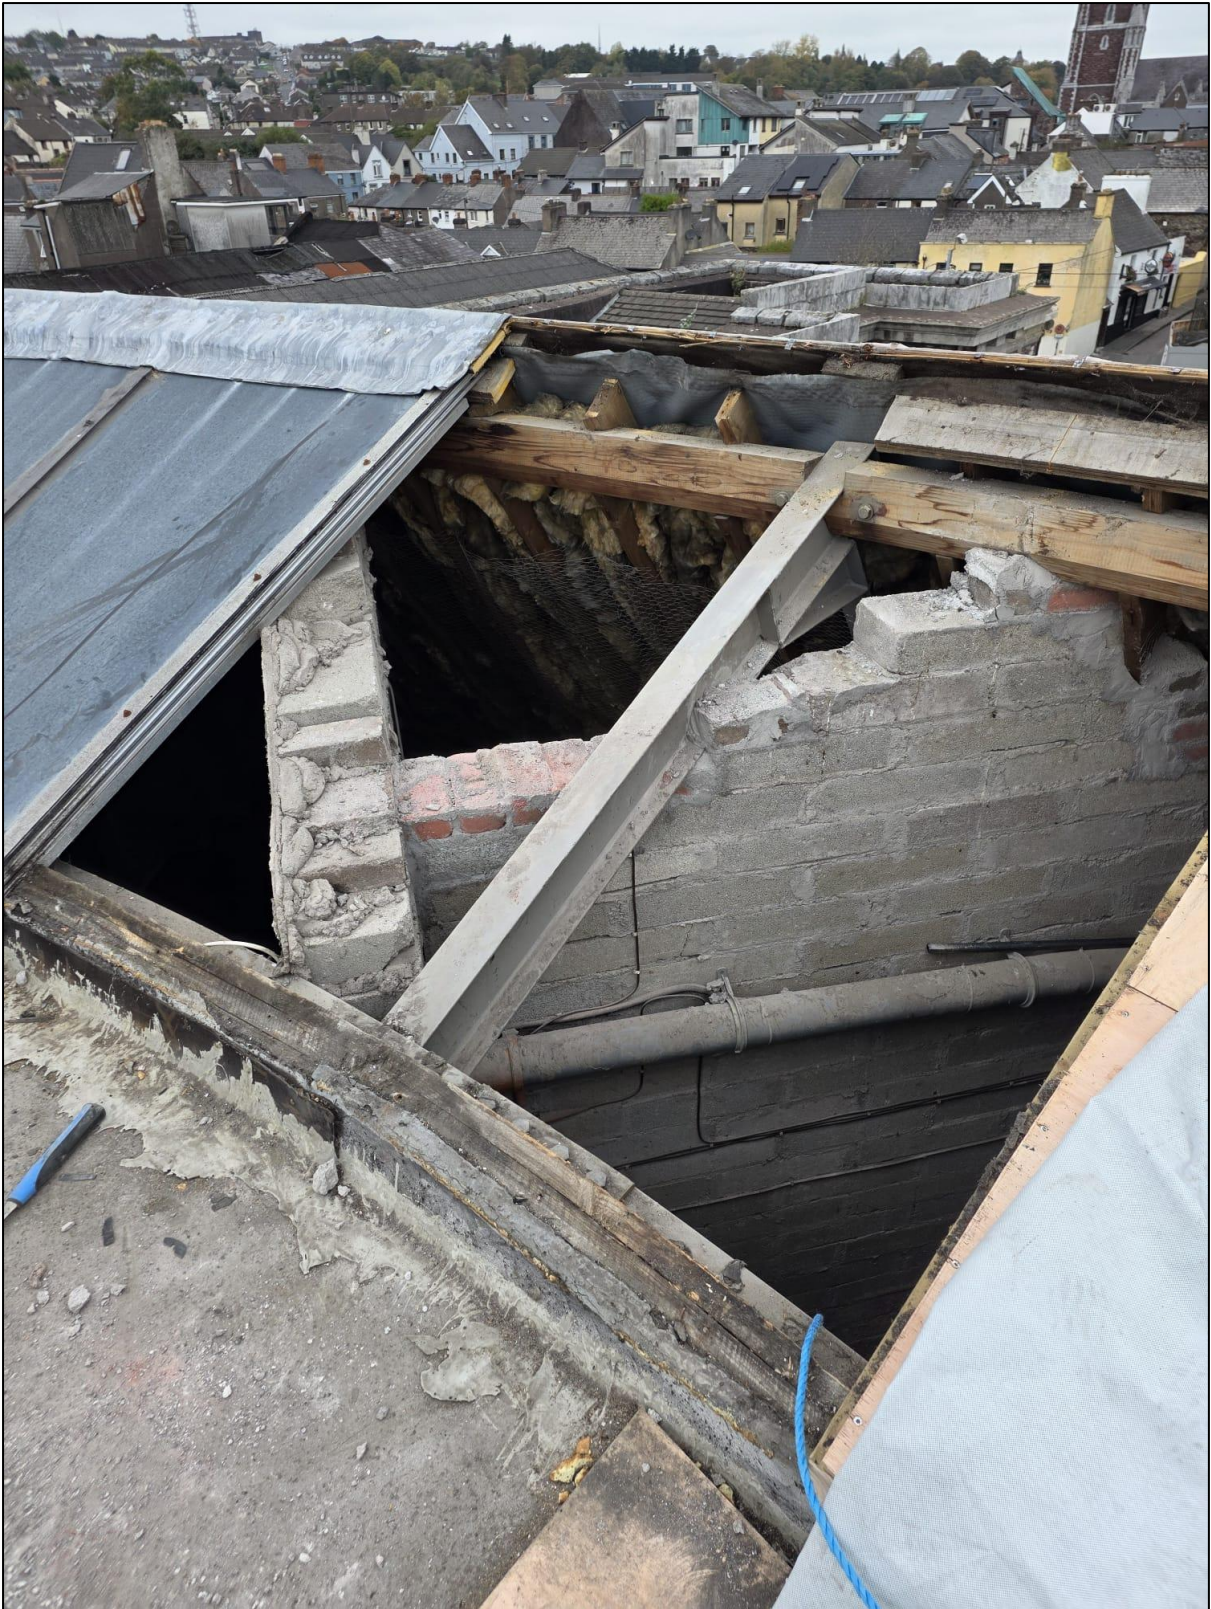
Plate 48 Walls are not sound proofed between rooms. Plate 49 Complex roof structure in good condition.

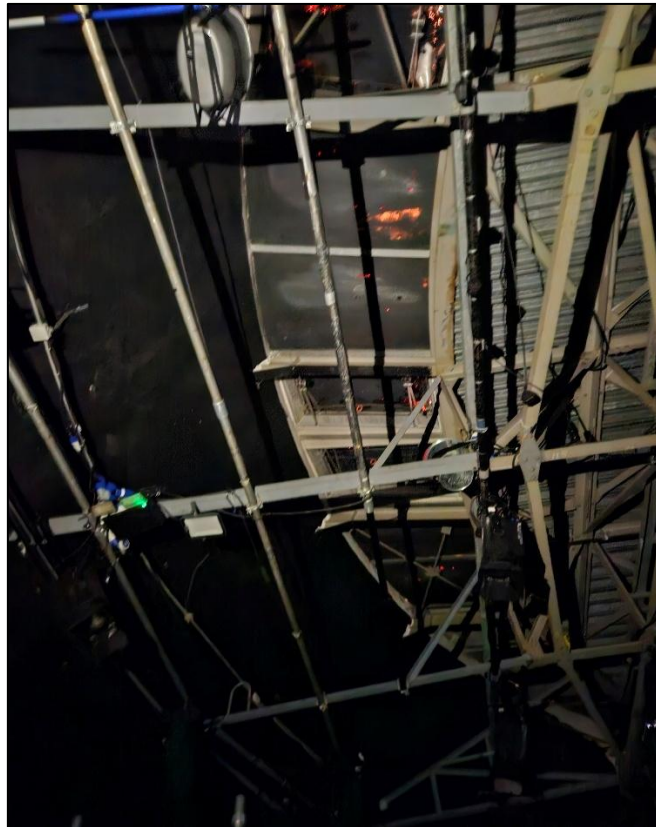
Plate 51 complex roof structure in good condition.

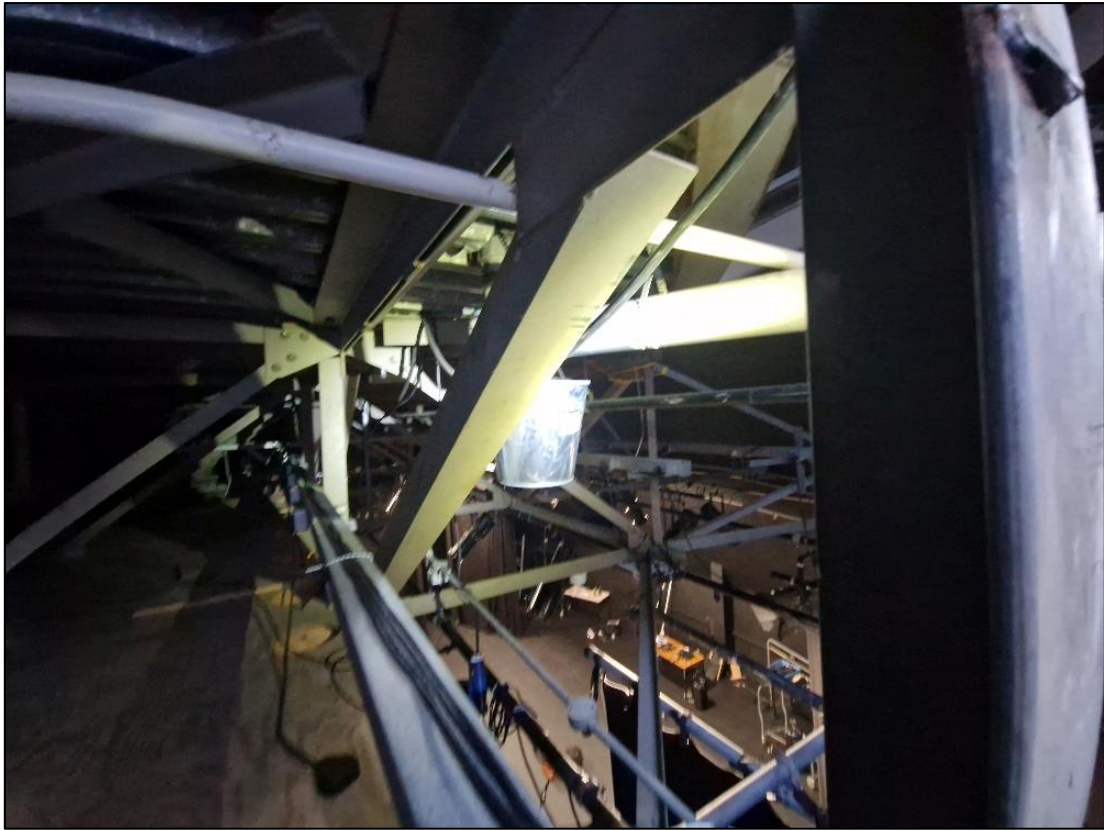
Plate 52 Complex roof structure in good condition.

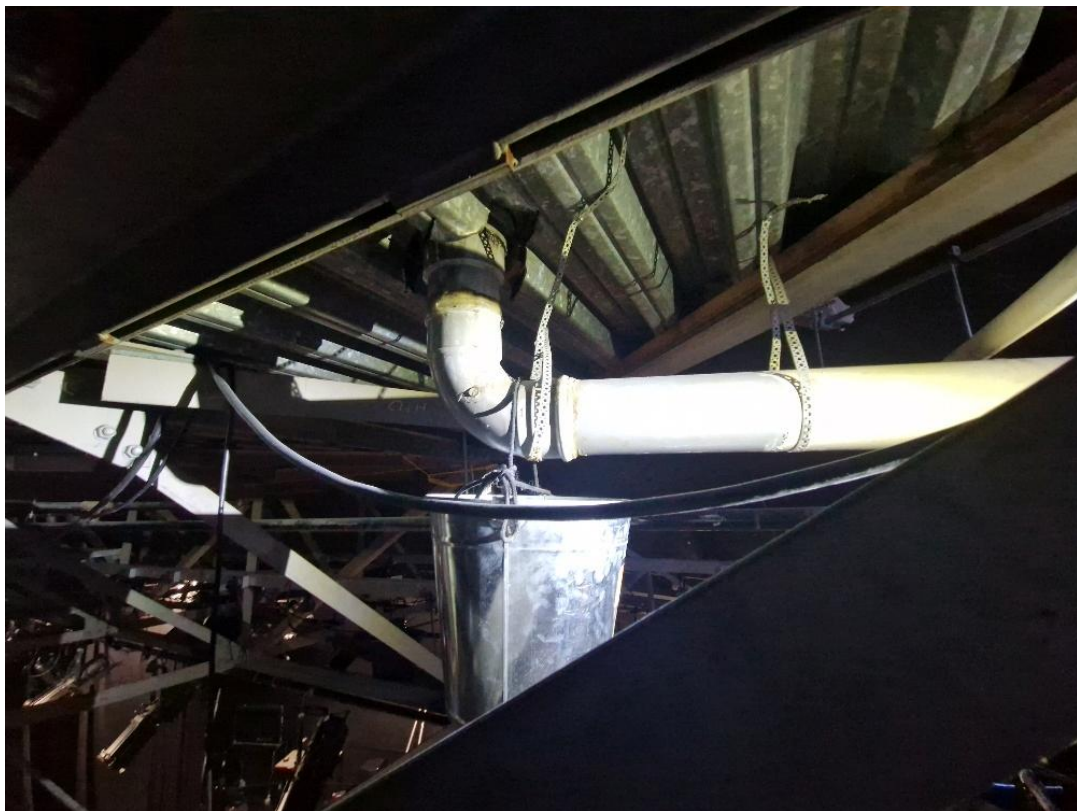
Plate 53 Shows problems with roof leaks currently being addressed in 2025 repairs

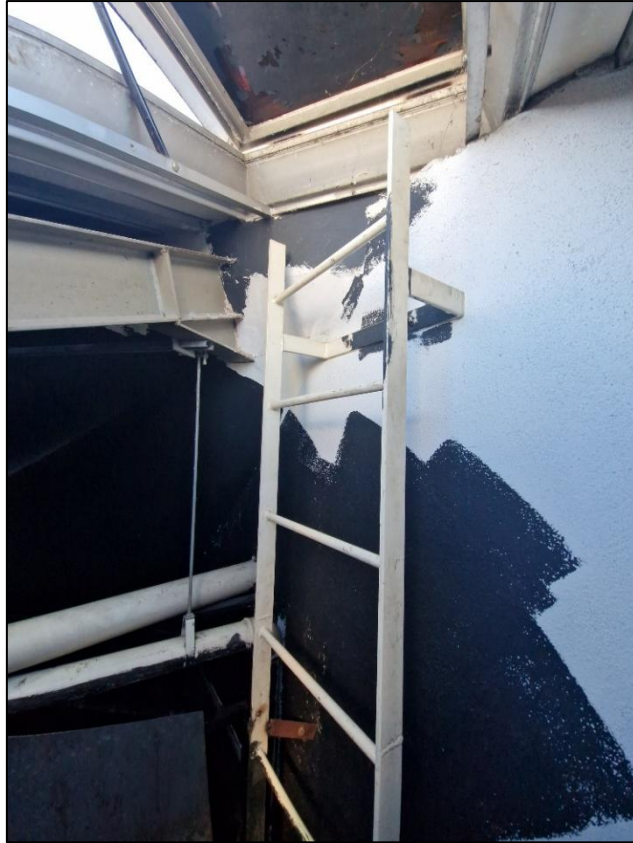
Plate 54 Awkward access to the roof needs to be improved.

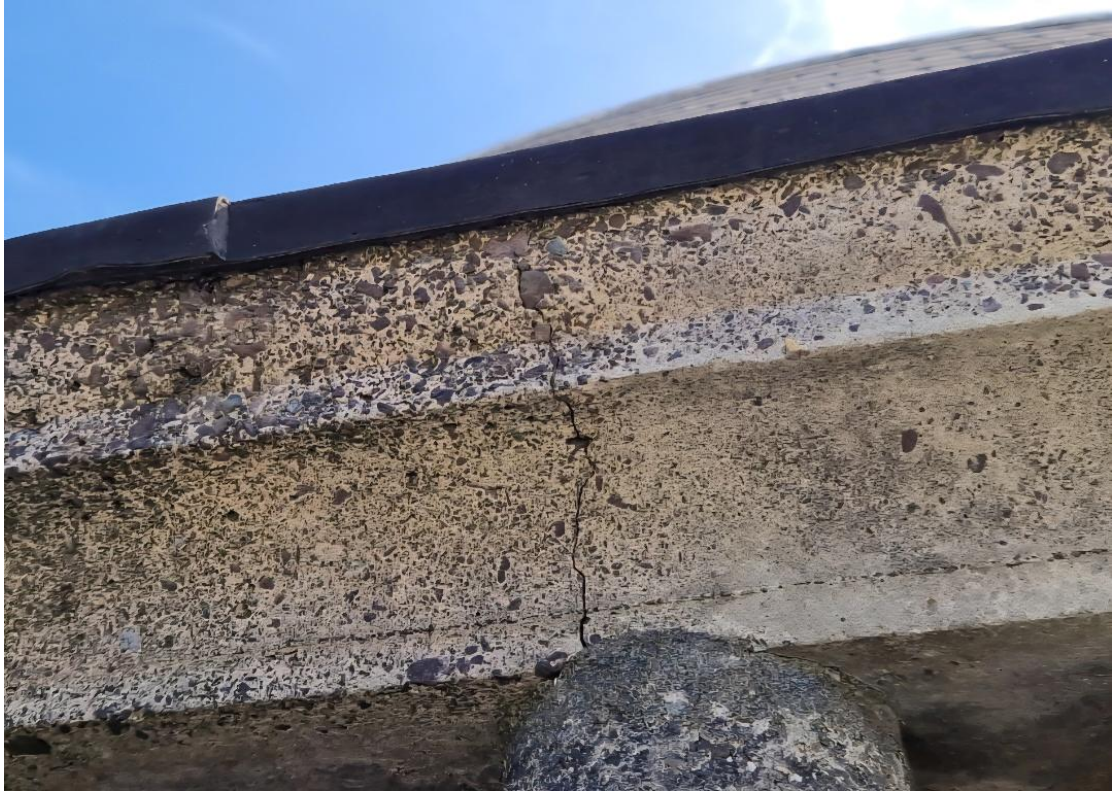
Plate 58 Crack repair and flashing repair are planned for 2026.

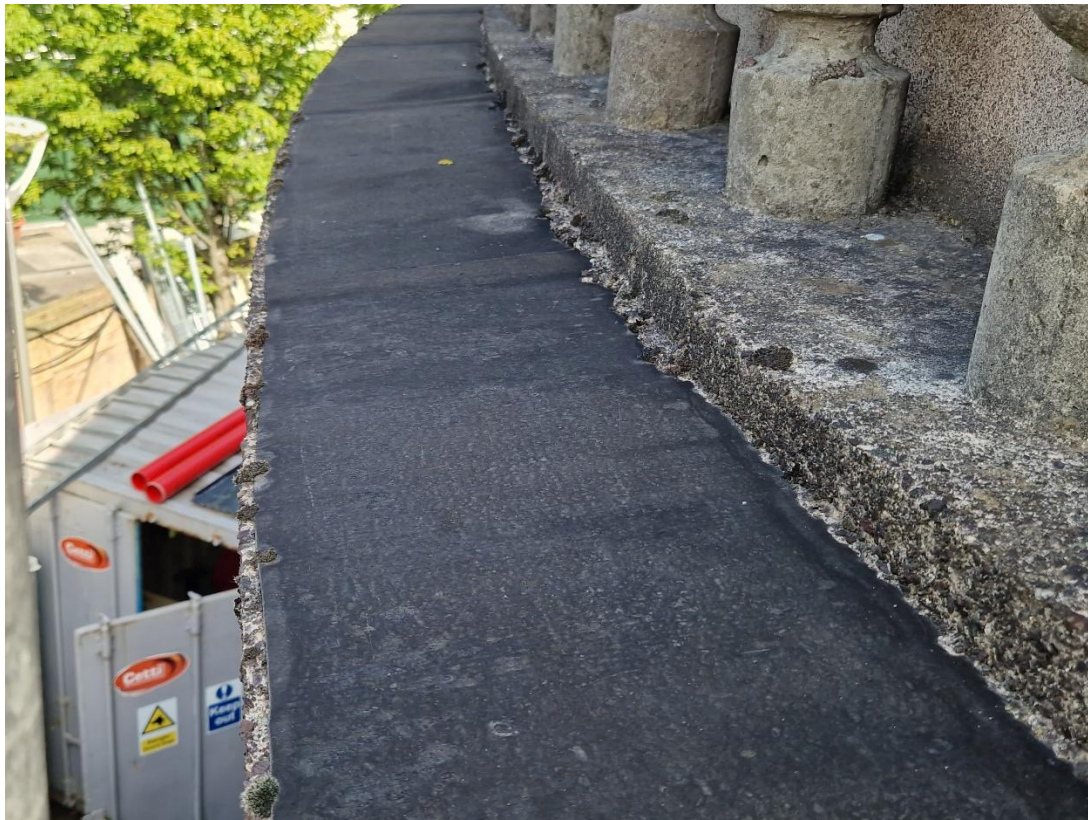
Plate 59 Torch on flashing stops short of the lip edge of the parapet resulting in water staining. To be addressed in 2026.

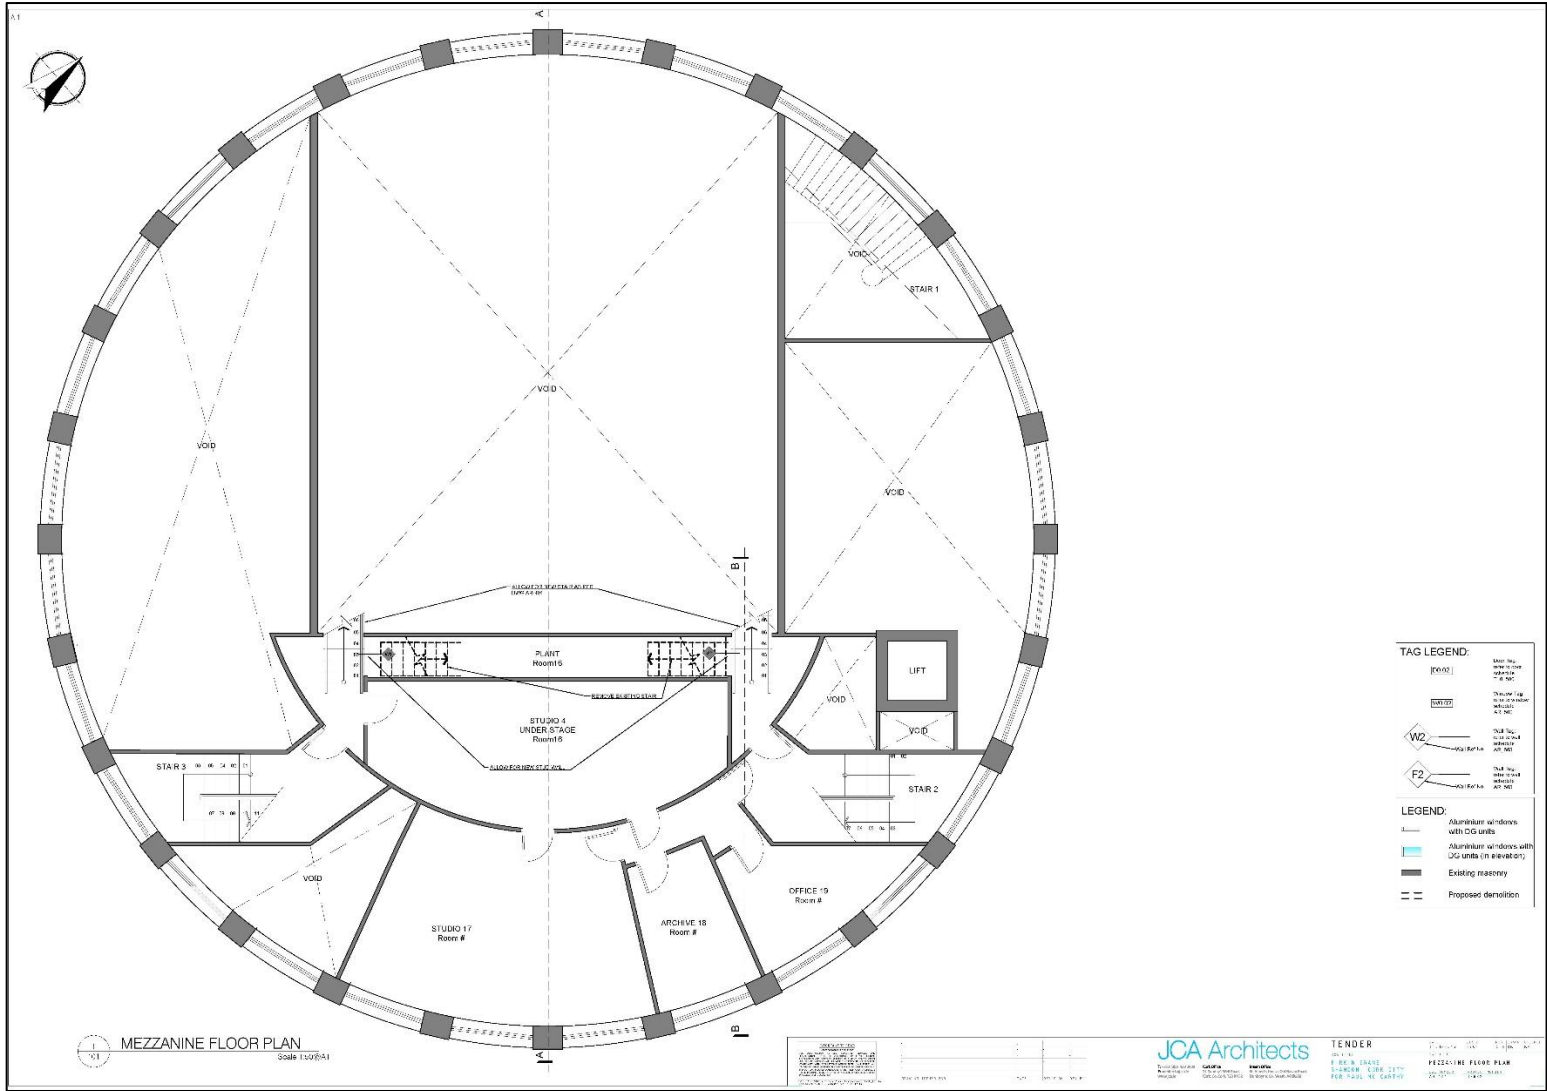
Drawing 3 Mezzanine Floor Plan

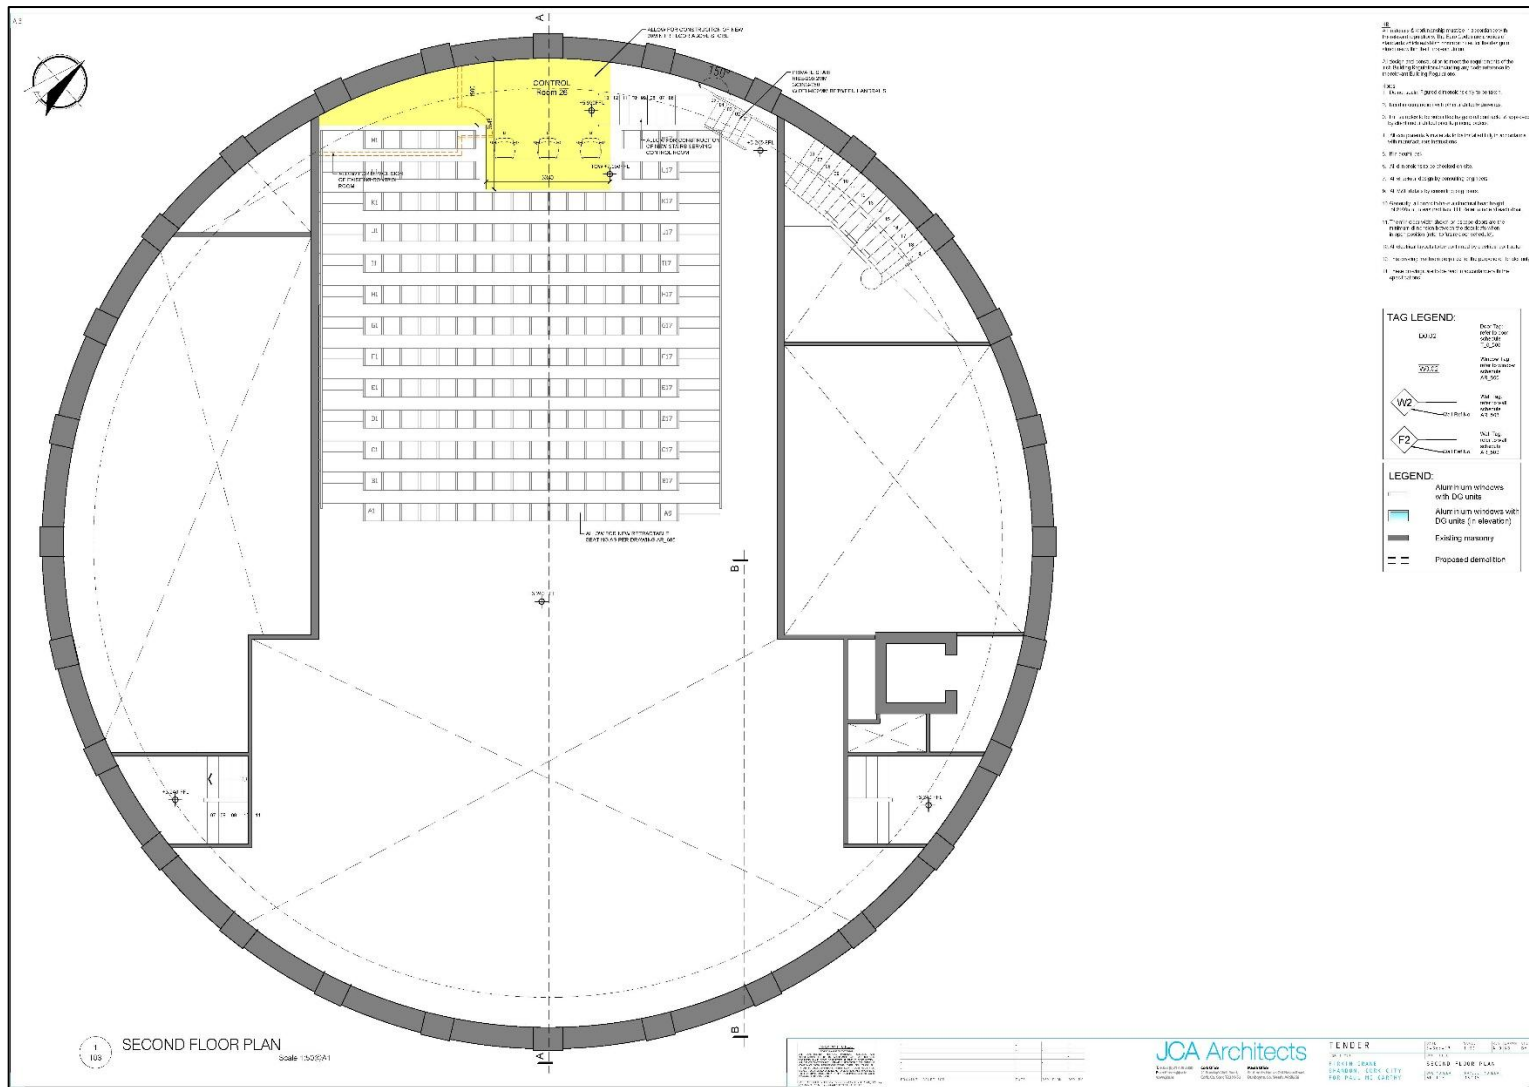
Drawing 5 second Floor Plan

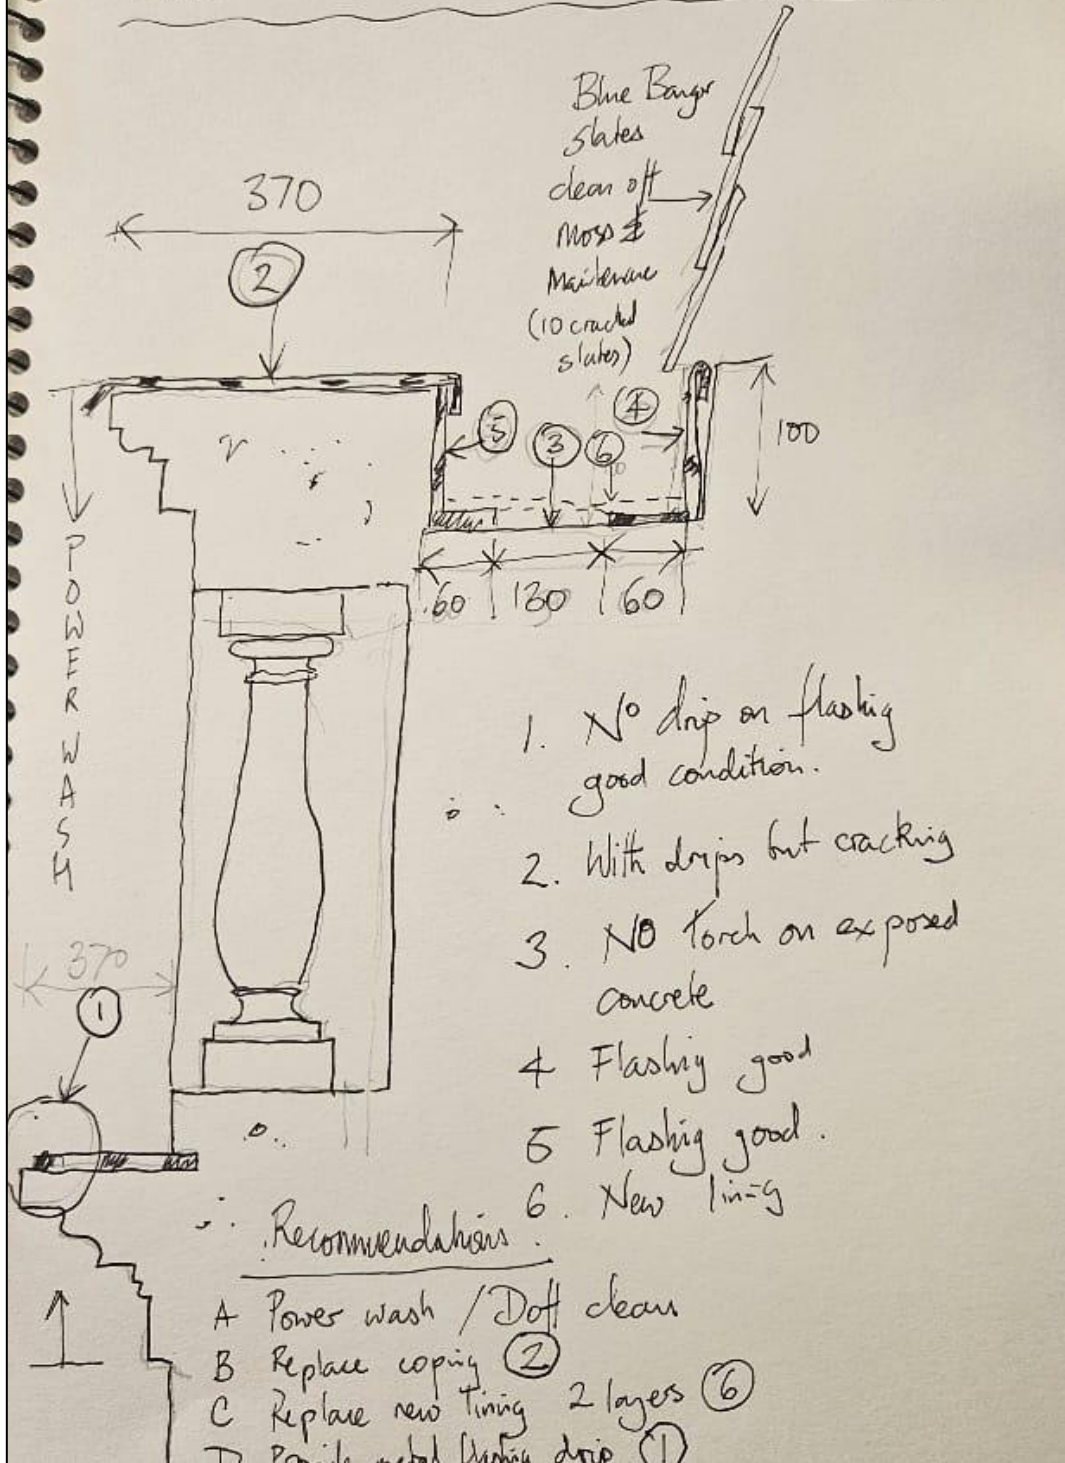
Drawing 7 Parapet Survey Sketch with recommendations

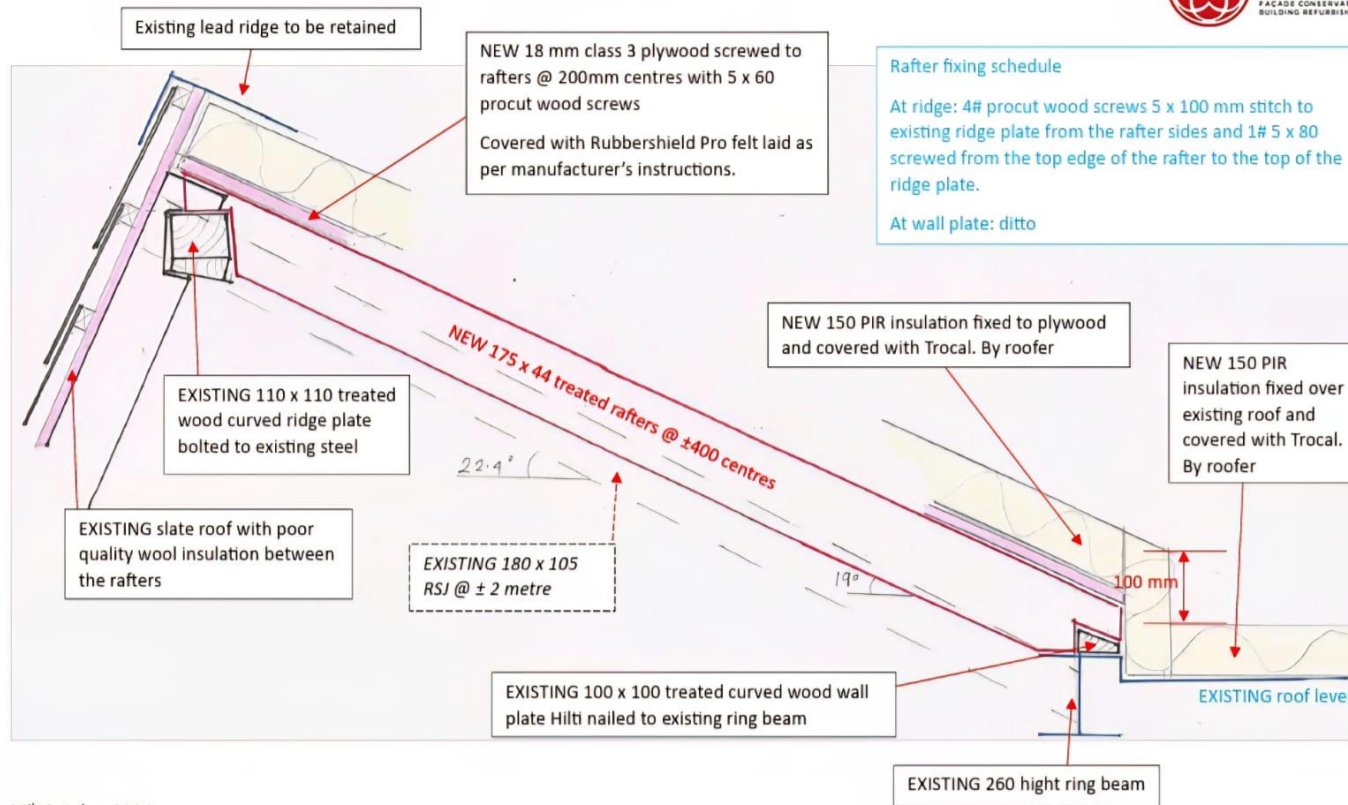
Cross section of upper roof detail- Not to scale

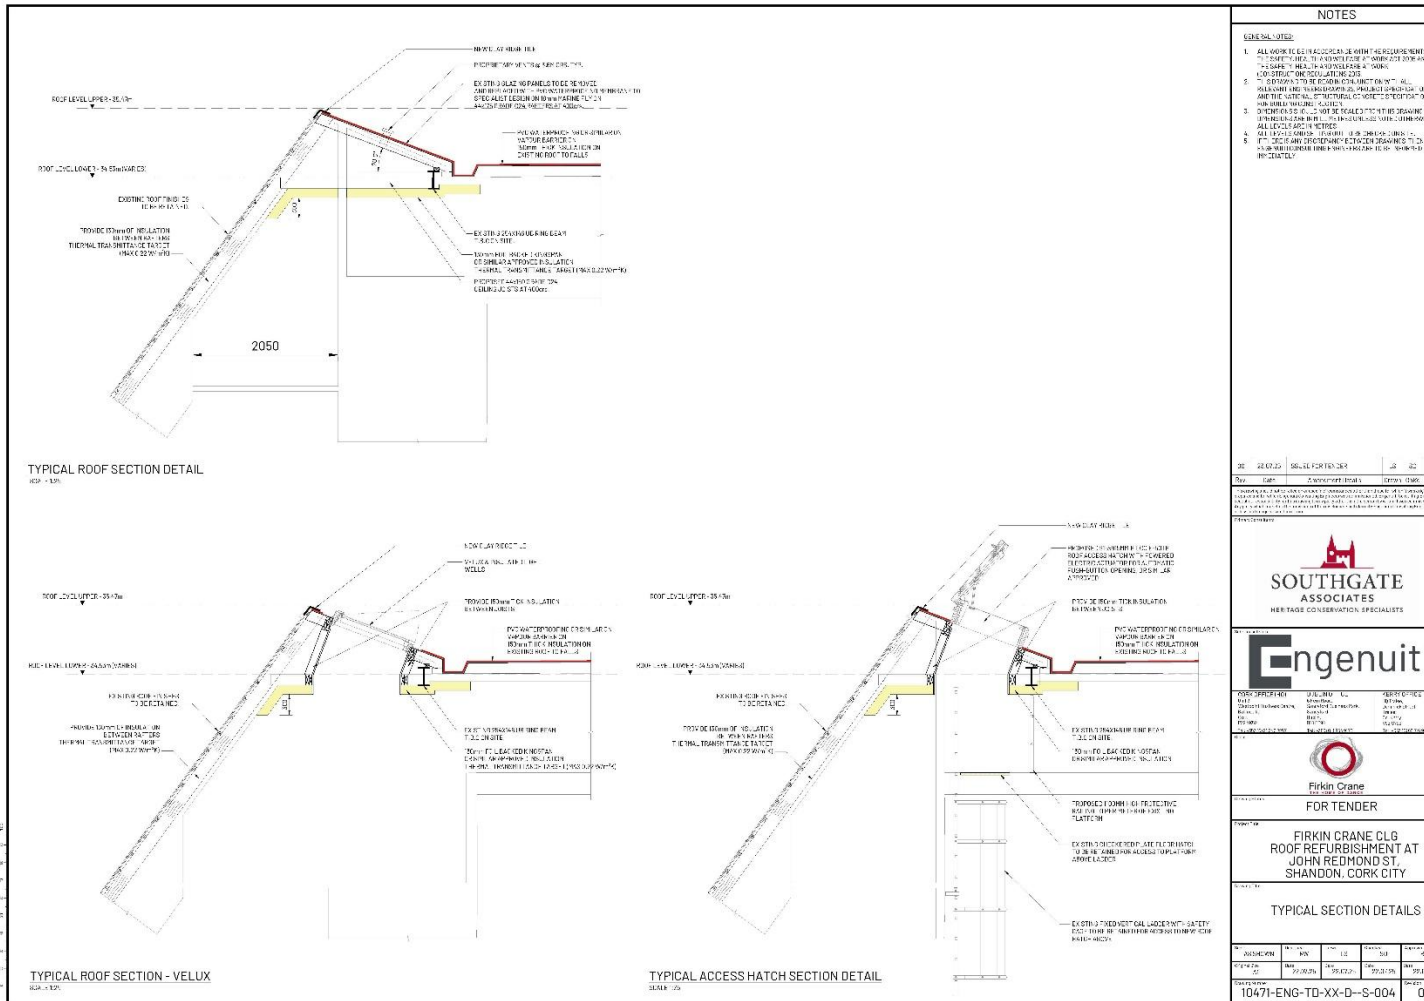
Drawing 9 Proposed conservation and repair drawing – Velux Roof light detail and typical access hatch section detail.

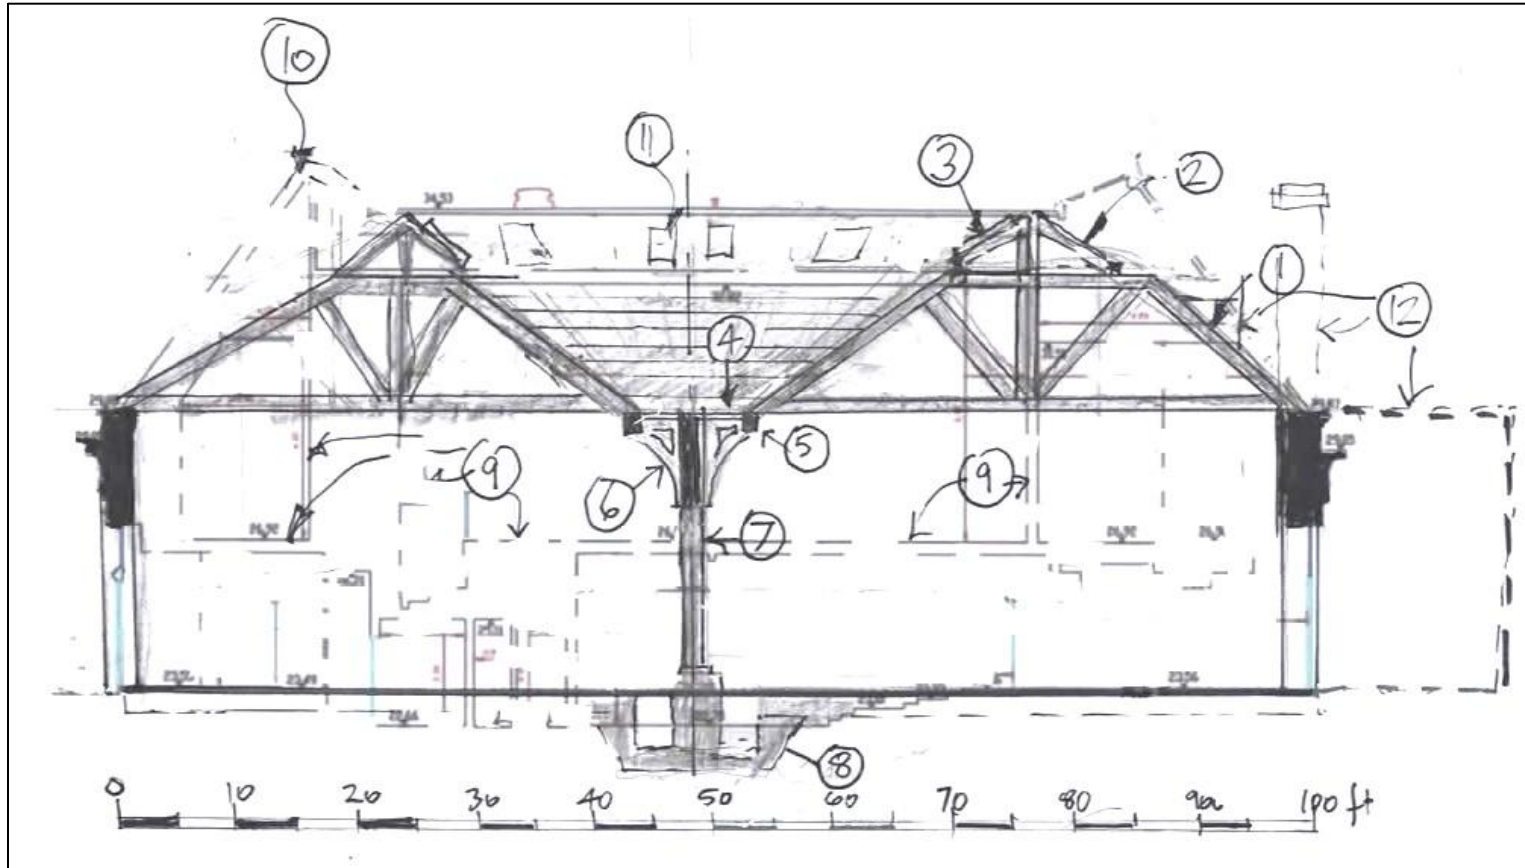
Drawing 10 Interpretative reconstruction of original 1855 roof structure
